Deepwater Horizon Incident Evaluation of the Breached Barriers

Document Number	SXBUSR048			
Revision	Issue Date	Prepared by	Reviewed by	Approved by
Final Revision	10/08/2021	Eric Wesselingh	Mark Gillard, Juliana Bond	Bryan Atchison
<p>Safe Influx Ltd. Bryan Atchison, Managing Director, bryan.atchison@safeinflux.com +44 (0) 7912 242421</p>				
<p>© 2021 This document contains proprietary information and shall not be reproduced or transferred to other documents or disclosed to others or used for any purpose other than for which it is furnished without the prior written permission of Safe Influx Ltd.</p>

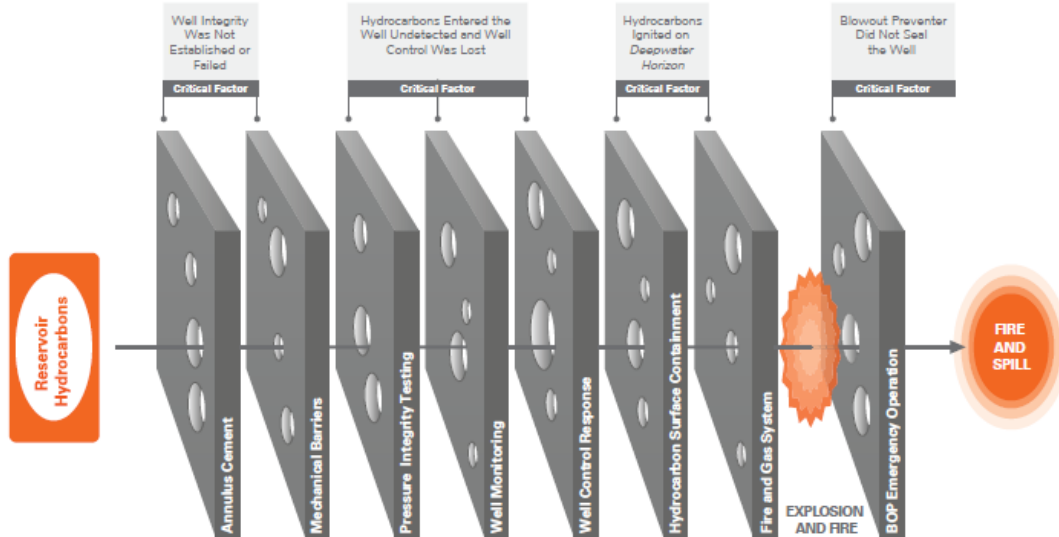
Figure 1 - Barriers Breached and the relationship of Barriers to the critical Factors (BP 2010)

In Figure 1, the eight blocks represent the defensive physical or operational barriers that were in place to eliminate or mitigate hazards. The holes represent failures or vulnerabilities in the defensive barriers. The eight key findings are represented by the holes that lined up to enable the accident to occur.

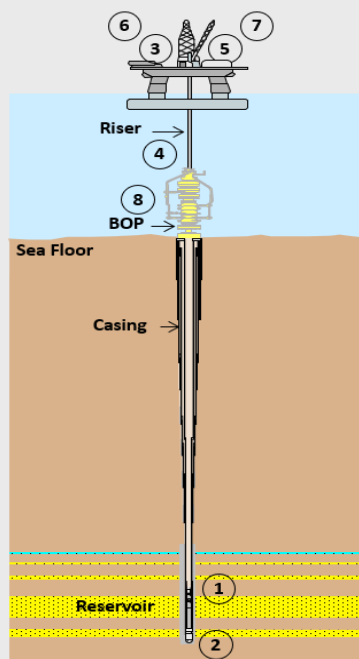
Figure 2 - Breached Barriers Summary (BP 2010)

A. Well integrity was not established or failed

- ① Annulus cement barrier did not isolate hydrocarbons
- ② Shoe track barriers did not isolate hydrocarbons

B. Hydrocarbons entered the well undetected and well control was lost

- ③ Negative pressure test was accepted although well integrity had not been established
- ④ Influx was not recognized until hydrocarbons were in riser
- ⑤ Well control response actions failed to regain control of well

C. Hydrocarbons ignited on the *Deepwater Horizon*

- ⑥ Diversion to mud gas separator resulted in gas venting onto rig
- ⑦ Fire and gas system did not prevent hydrocarbon ignition

D. Blowout preventer did not seal the well

- ⑧ Blowout preventer (BOP) emergency modes did not seal well
