Deepwater Horizon Incident Evaluation of the Breached Barriers

Document Number	SXBUSR048			
Revision	Issue Date	Prepared by	Reviewed by	Approved by
Final Revision	26/08/2021	Eric Wesselingh	Mark Gillard, Juliana Bond	Bryan Atchison
<p>Safe Influx Ltd. Bryan Atchison, Managing Director, bryan.atchison@safeinflux.com +44 (0) 7912 242421</p>				
<p>© 2021 This document contains proprietary information and shall not be reproduced or transferred to other documents or disclosed to others or used for any purpose other than for which it is furnished without the prior written permission of Safe Influx Ltd.</p>

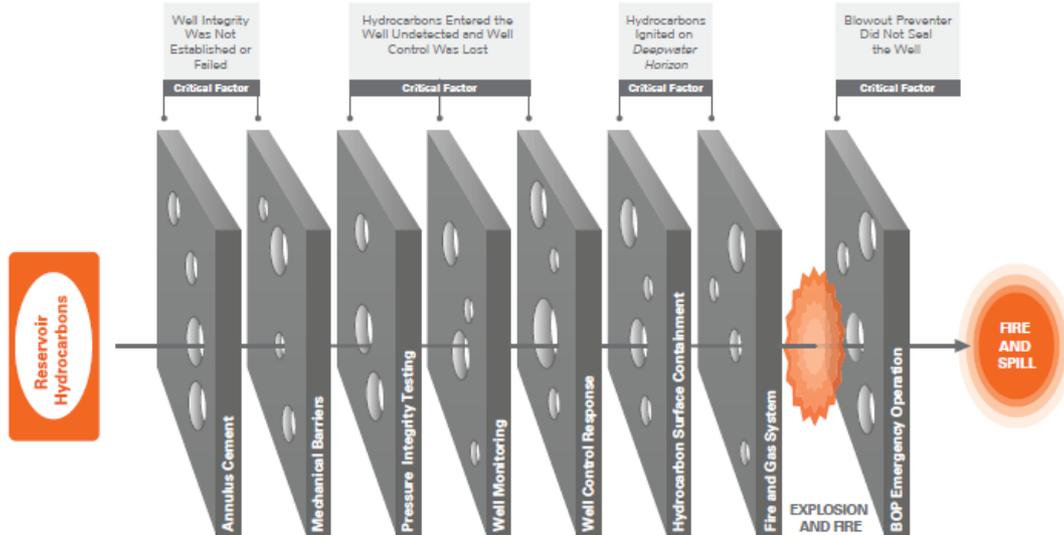
Figure 1 - Barriers Breached and the relationship of Barriers to the critical Factors

In Figure 1, the eight blocks represent the defensive physical or operational barriers that were in place to eliminate or mitigate hazards. The holes represent failures or vulnerabilities in the defensive barriers. The eight key findings are represented by the holes that lined up to enable the accident to occur.

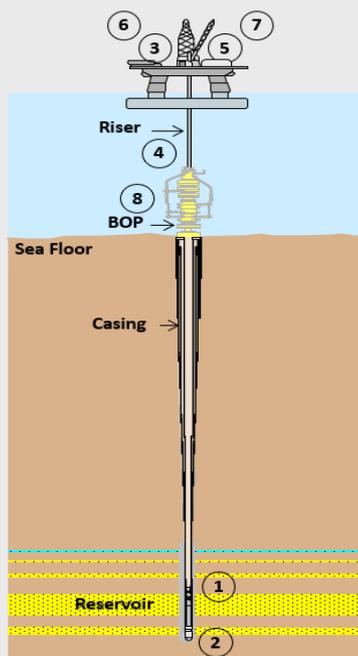
Figure 2 - Breached Barriers Summary (BP 2010)

A. Well integrity was not established or failed

- ① Annulus cement barrier did not isolate hydrocarbons
- ② Shoe track barriers did not isolate hydrocarbons

B. Hydrocarbons entered the well undetected and well control was lost

- ③ Negative pressure test was accepted although well integrity had not been established
- ④ Influx was not recognized until hydrocarbons were in riser
- ⑤ Well control response actions failed to regain control of well

C. Hydrocarbons ignited on the *Deepwater Horizon*

- ⑥ Diversion to mud gas separator resulted in gas venting onto rig
- ⑦ Fire and gas system did not prevent hydrocarbon ignition

D. Blowout preventer did not seal the well

- ⑧ Blowout preventer (BOP) emergency modes did not seal well

- 1) **Annulus Cement Barrier** - The day before the accident, cement had been pumped down the production casing and up into the wellbore annulus to prevent hydrocarbons from entering the wellbore from the reservoir. This annulus cement probably experienced nitrogen breakout and migration, allowing hydrocarbons to enter the wellbore annulus.

- 2) **Shoe Track Barrier** - Hydrocarbons then entered the production casing through the shoe track. Hydrocarbons entered the casing rather than the annulus suggesting that both barriers in the shoe track must have failed (first barrier – cement shoe track, second barrier – float collar).

- 3) **Negative Pressure Test** - Prior to the temporary abandonment of the well, a negative pressure test was conducted to verify the integrity of the mechanical barriers (shoe track, production casing and casing hanger seal assembly). In retrospect, pressure readings and volume bled at the time of the test were indications of flow-path communication with the reservoir, signifying that the integrity of these barriers had not been achieved.

- 4) **Influx not Recognized** - With the negative pressure test having been accepted, the well was returned to an overbalanced condition, preventing further influx into the wellbore. Later, as part of the temporary abandonment program, mud was replaced with seawater, putting the well in an underbalanced condition. Over time, this allowed hydrocarbons to flow up through the production casing and pass the blowout preventer (BOP). Indication of an influx with an increase in drill pipe pressure are discernable in real-time data from approximately 40 minutes before the crew took action to control the well.

- 5) **Well Control Response Actions** - The first well control action was to close the BOP and diverter, routing the fluids exiting the riser to the mud gas separator (MGS) rather than the overboard diverter line.

- 6) **Diversion to MGS** - Once diverted to the MGS, hydrocarbons vented directly onto the rig through the derrick vent and other flow paths connected to the MGS (the MGS was overwhelmed due to the high flow condition).

- 7) **Fire and Gas Detection System** - Hydrocarbons migrated beyond areas on the Deepwater Horizon that were electrically classified to areas where the potential for ignition was higher.

- 8) **BOP Emergency Mode** - The three methods for operating the BOP in the emergency mode were unsuccessful.
 - The explosion and fire likely disabled the emergency disconnect sequence,

- Condition of critical components in the yellow and blue control pods likely prevented activation of the automatic mode function (AMF),
 - the autoshear function initiated by a remote operated vehicle, likely resulted in the BOP blind/shear ram (BSR) closing, but the BSR failed to seal the well.
